## **Demonstration and Validation of a Lightweight Composite Bridge Deck Technology as an Alternative to Reinforced Concrete**

Final Report on Project F09-AR16

August 2016

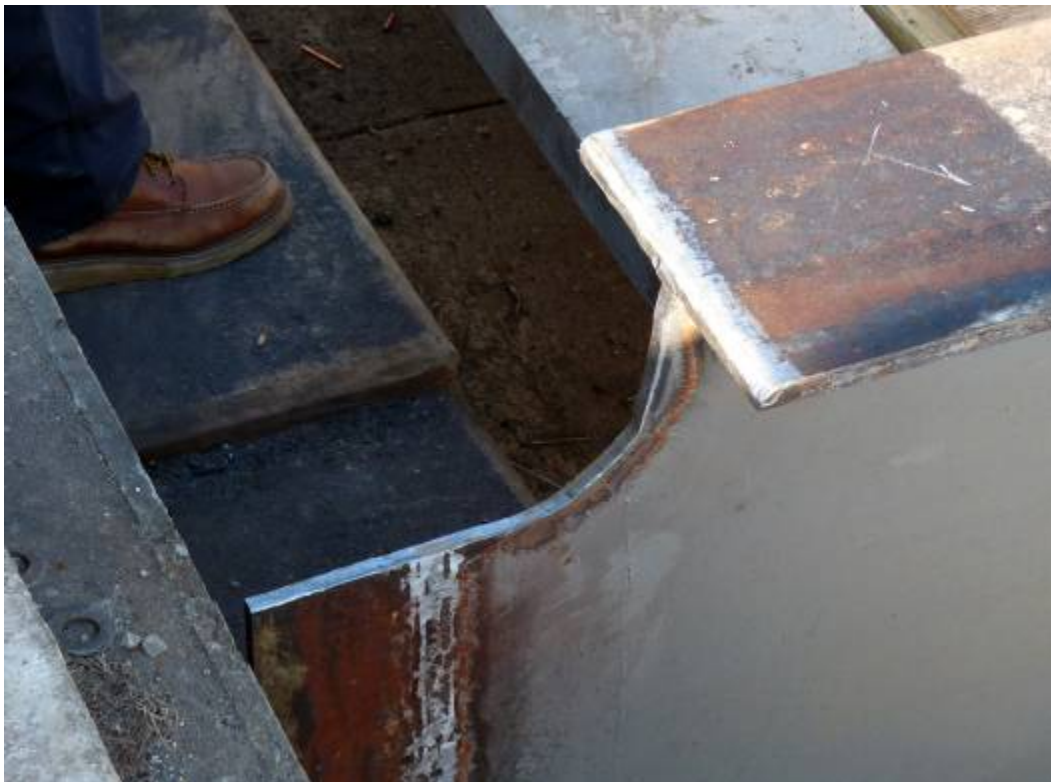
Figure 10. Girder with corroded section removed.

Next the girders were cleaned, inspected and rehabilitated. The inspection revealed that the upper corners of the girder ends needed to be replaced due to extensive corrosion. Figure 10 through Figure 12 show an end of a girder with the section removed, the extent of corrosion damage, and the repaired girder. Also the southeastern-most girder section was replaced in its entirety due to corrosion and impact damage. All girder refurbishment was performed by Redstone Arsenal DPW and was not part of the CPC project.

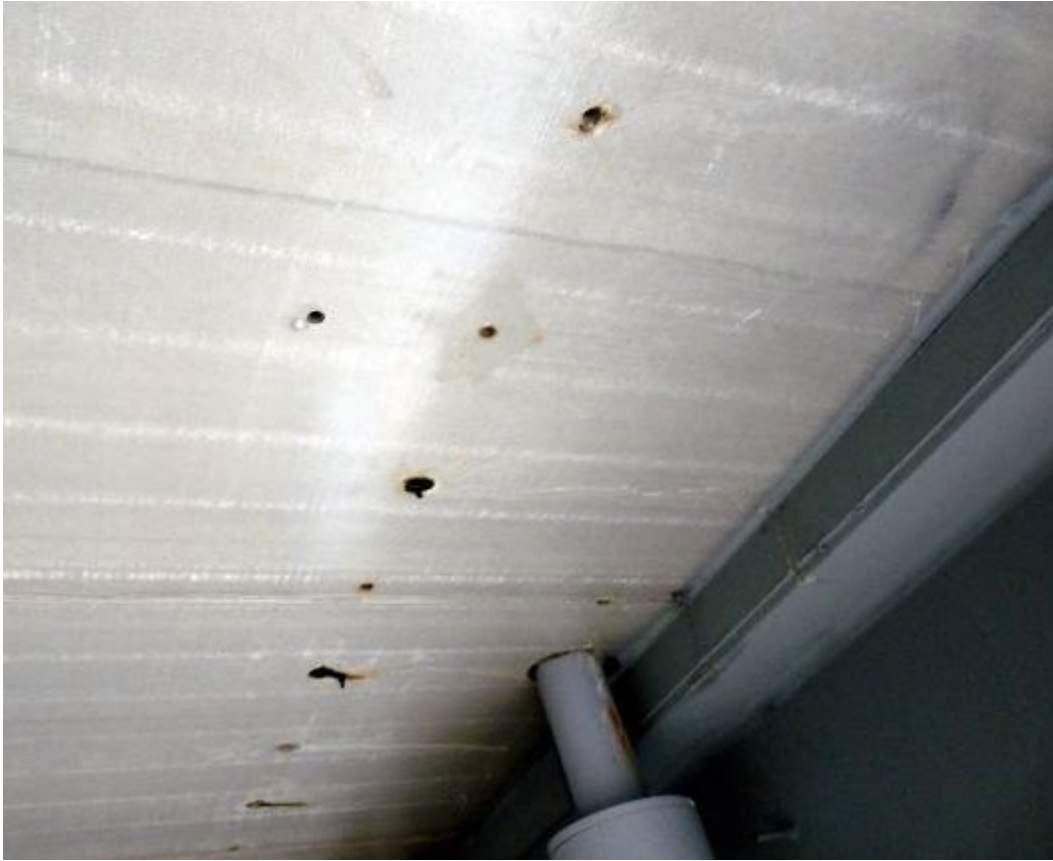
Figure 63. Additional weep hole drilled next to concrete-obstructed hole.

drainage through the half channels was interrupted by the grout pockets that had been created to encase the shear studs. As a consequence, any water that infiltrated the bridge deck “upstream” of these pockets was trapped by design. In addition, several weep holes had become plugged by concrete that escaped the barrier rail form facing the deck interior.

Because of the imminent onset of the winter freeze/thaw cycle in Huntsville, AL, immediate corrective action was undertaken to drill additional weep holes in the bottom of the deck. Overall, approximately 296 additional 0.5 in. diameter weep holes were drilled into the deck. Of those, approximately 90% drained in excess of 2 gallons of retained water (Figure 62). Finally, in locations where concrete was obstructing existing weep holes, MEC drilled replacement holes at higher elevations at 6 in. intervals until an unobstructed weep hole could be established (Figure 63).

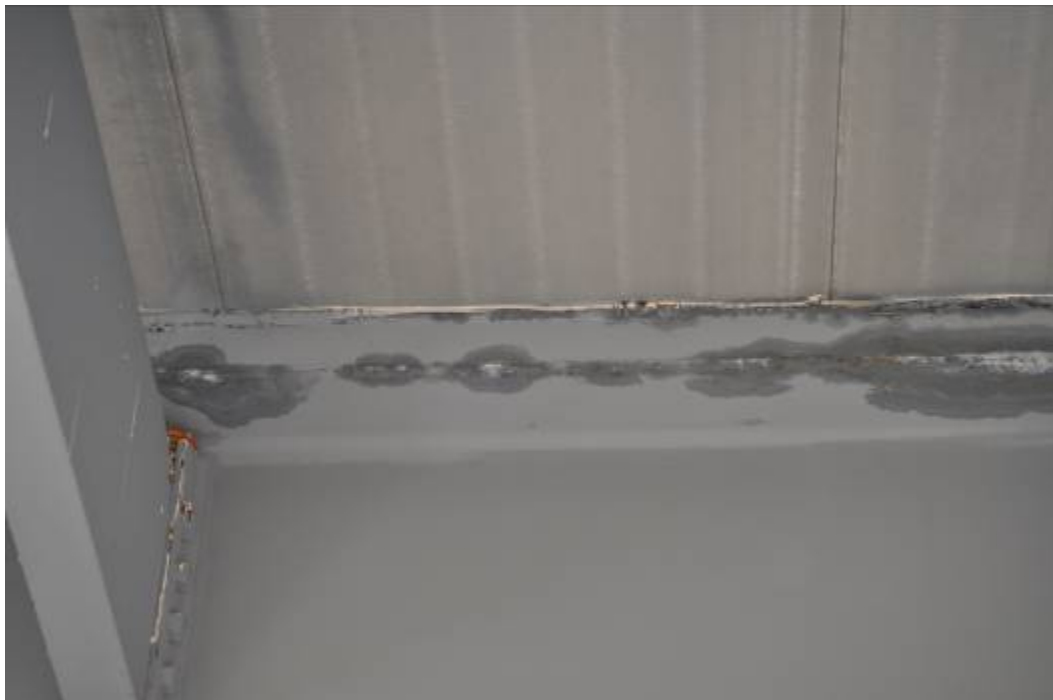
Figure 64. Moisture infiltrated through grout onto girder.

In addition to finding retained water, the inspection confirmed the reflective cracking in the wear surface and the presence of voids in the grout haunch. The inspection also found that a significant amount of water was migrating through the grout haunch, particularly near voids, causing water to accumulate on girders and create corrosive conditions (Figure 64).
